MUNITIONS STORAGE SITE SOUTHWEST OF SHANG-JAO, CHINA

CIA/PIR 63040

DATE MARCH 1966

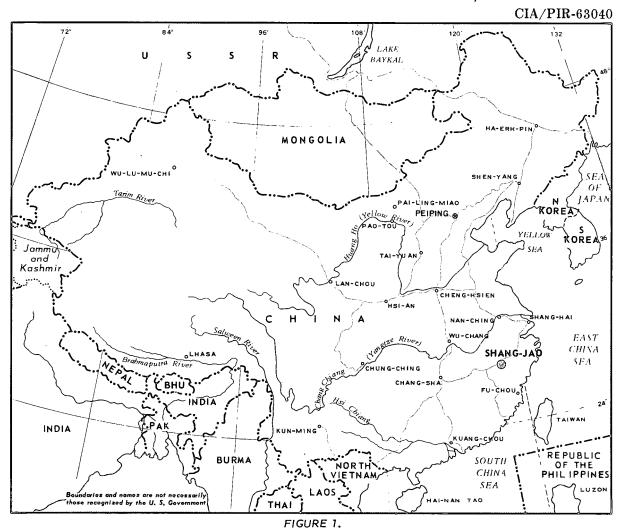
A previously identified munitions storage site is located at 28-22N 117-54E, 5.5 nautical miles (nm) southwest of Shang-jao, China (Figure 1). The site is road served and rail service is available at Shang-jao.

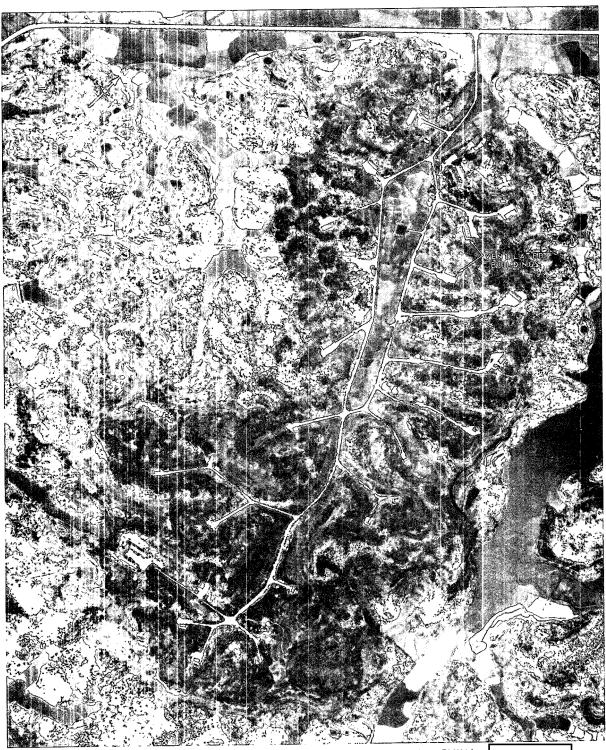
FIGURE 2. MUNITIONS STORAGE SITE SOUTHWEST OF SHANG-JAO, CHINA.

Storage facilities at the site include 25 gable-roofed ware-houses and 5 small support buildings. The warehouses seem to be of 2 basic sizes. Buildings 1-5 and 21-25 are approximately 10 by 25 meters, and Buildings 6-20 are about 6 by 11 meters. Two of the larger warehouses (Buildings 24 and 25, Figures 2 and 3) have monitor-type ventilators located along their roof peaks. Building 24 has 2 separate ventilators, whereas Building 25 appears to have only 1 long ventilator. The end walls of all the warehouses protrude above the roof lines. These walls, which appear to be of heavy construction, are probably blast walls. For additional blast protection, the warehouses have been located in small valleys and most are separated from each other by hills.

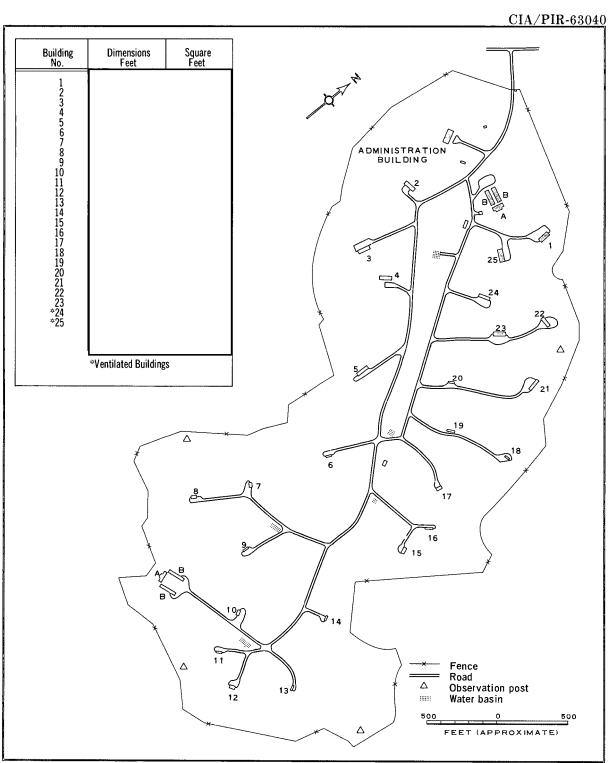
FIGURE 3. MUNITIONS STORAGE SITE SOUTHWEST OF SHANG-JAO, CHINA

Water basins are located throughout the site as indicated in Figure 3. The probable function of these basins is to provide water for fire fighting.

The entire site is secured by a single fence. A guard post is located at the entrance to the site, and 4 observation posts can be seen at high points around the perimeter (Figure 3). The trails which follow the fenceline and connect the observation posts probably serve as patrol paths also.

The housing and administration facilities include 1 administration buildings, 4 barracks (Buildings B, Figure 3) and 2 small messhalls (Buildings A, Figure 3). The administration building is located 500 feet inside the entrance on the west side of the road (Figure 3). Two barracks and a small messhall are located across the road from the administration building. A similar combination of 2 barracks and a messhall is located in the southern portion of the site.
